**Re: GE-Pittsfield/Housatonic River Site  
Silver Lake Area (GECD600)  
2018 Annual Monitoring Report**

# 2018 ANNUAL MONITORING REPORT

Silver Lake Area

February 2019

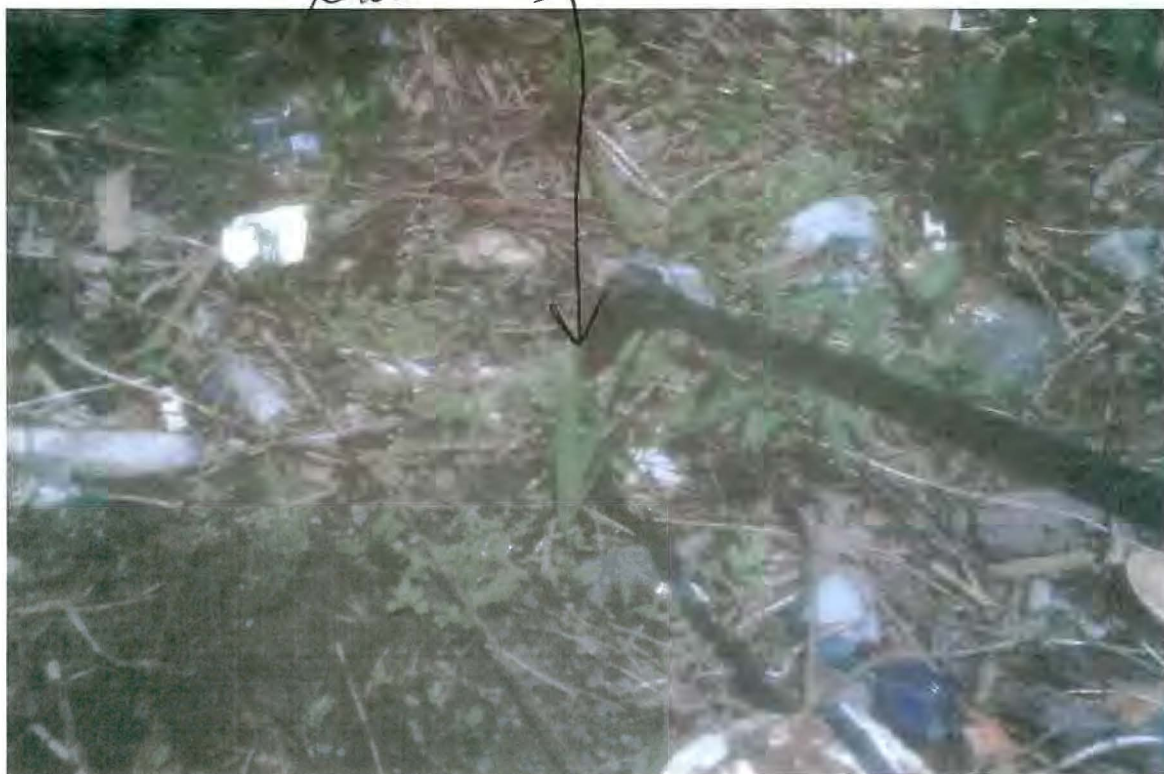
PURPLE LOOSESTRIFE !!!

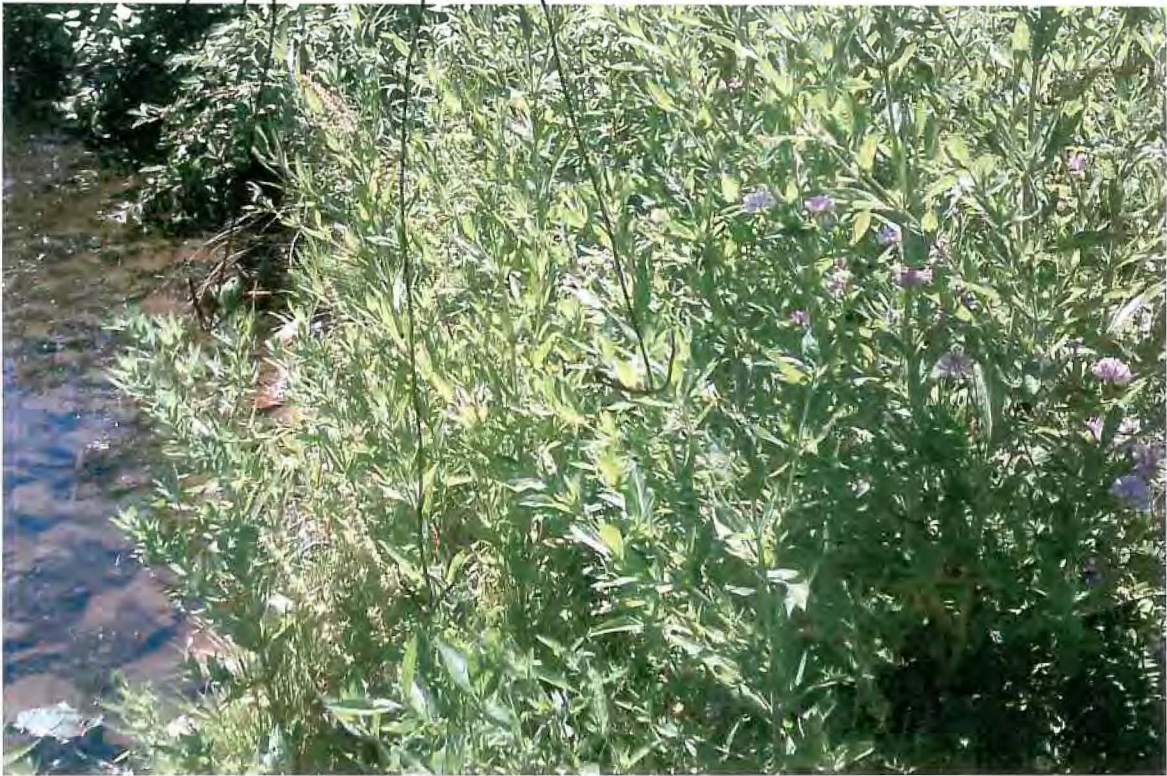
DEAD JAPANESE KNOTWEED

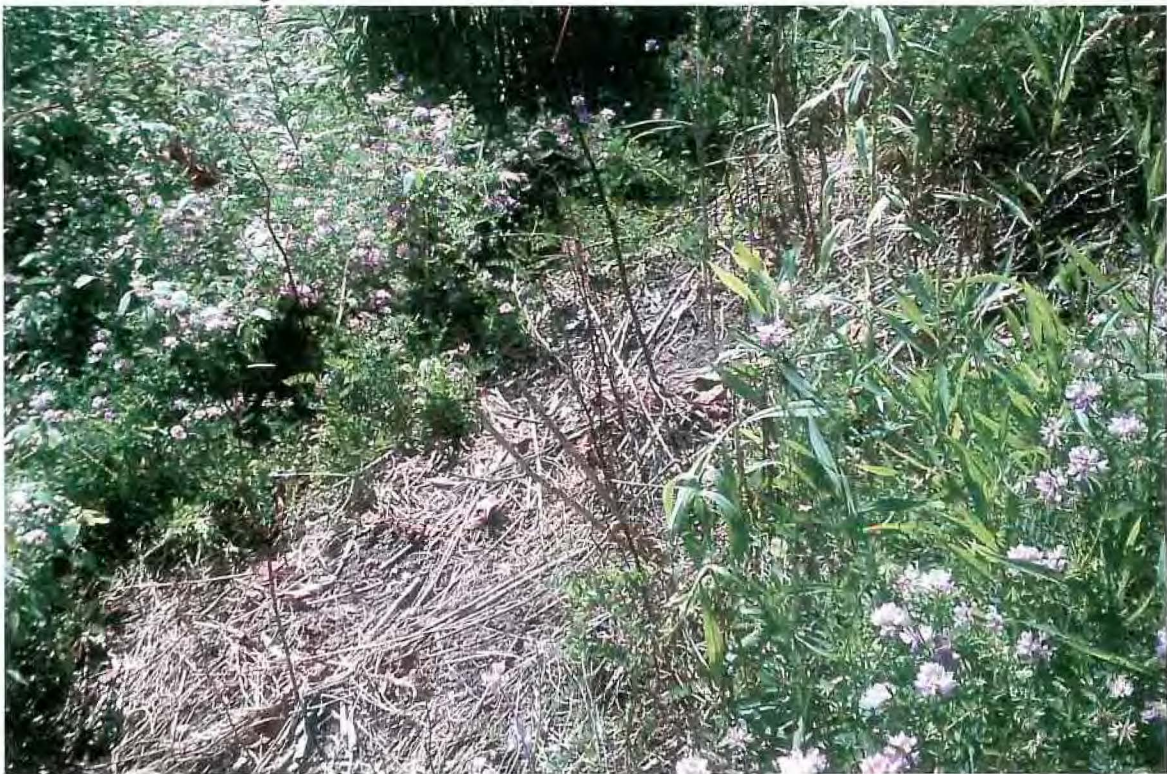
PURPLE LOOSESTRIPE REMOVED

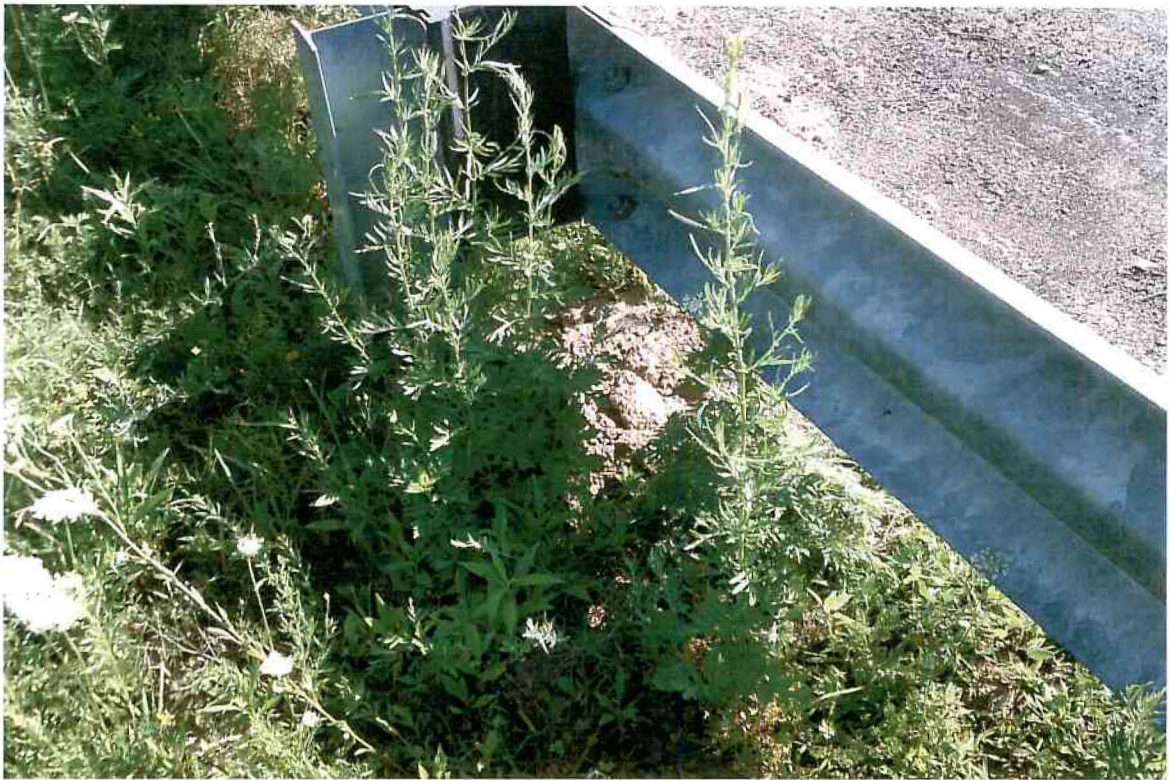
PURPLE LOOSESTRIFE

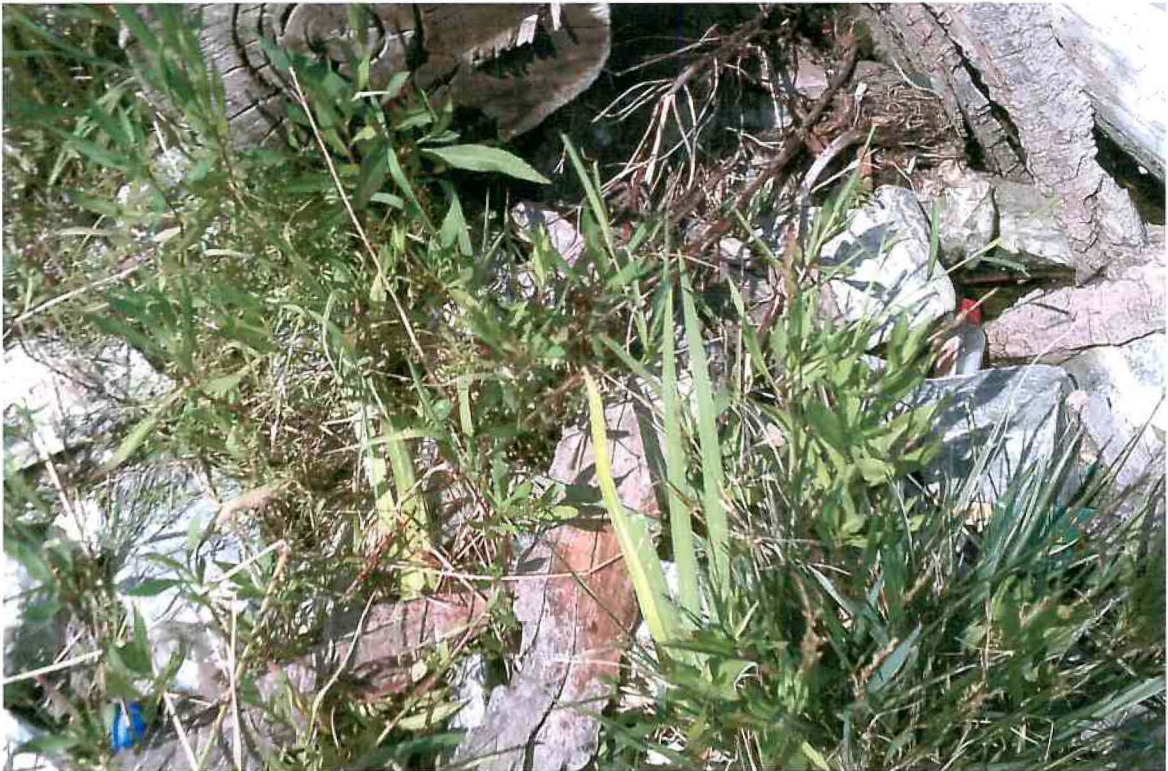
Purple Loosestrife & Colt's Foot

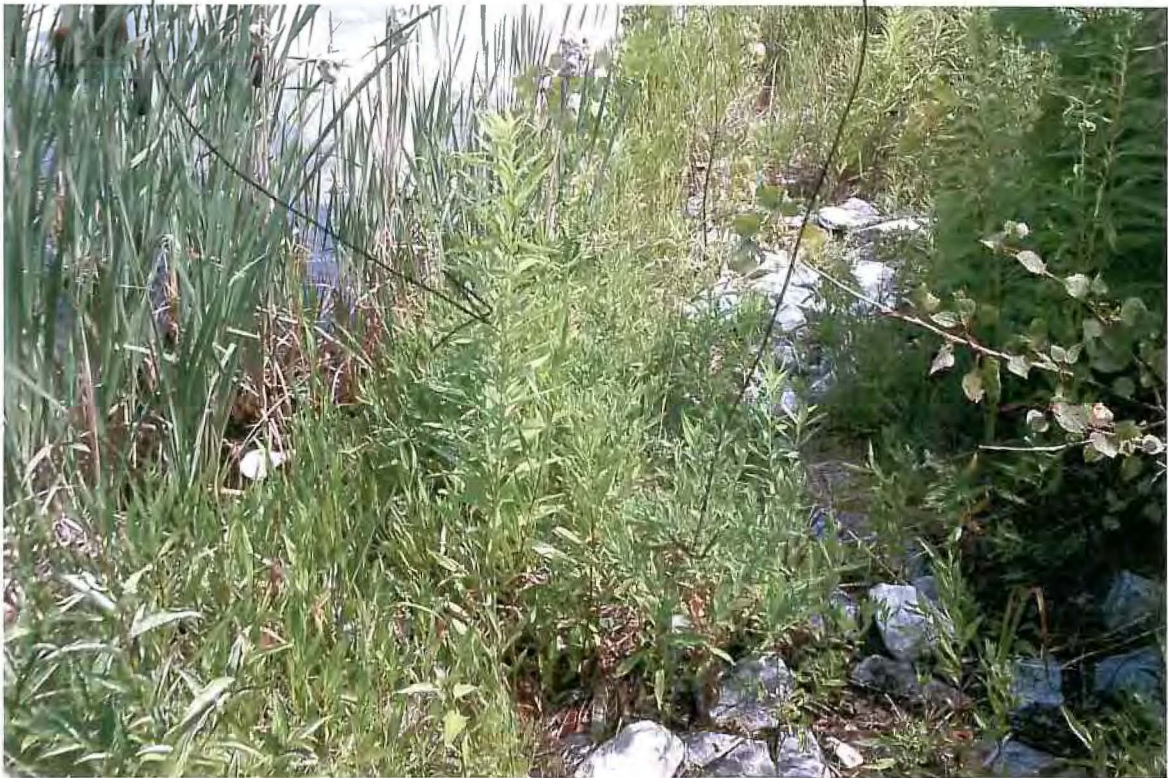
Mugwort and spotted knapweed

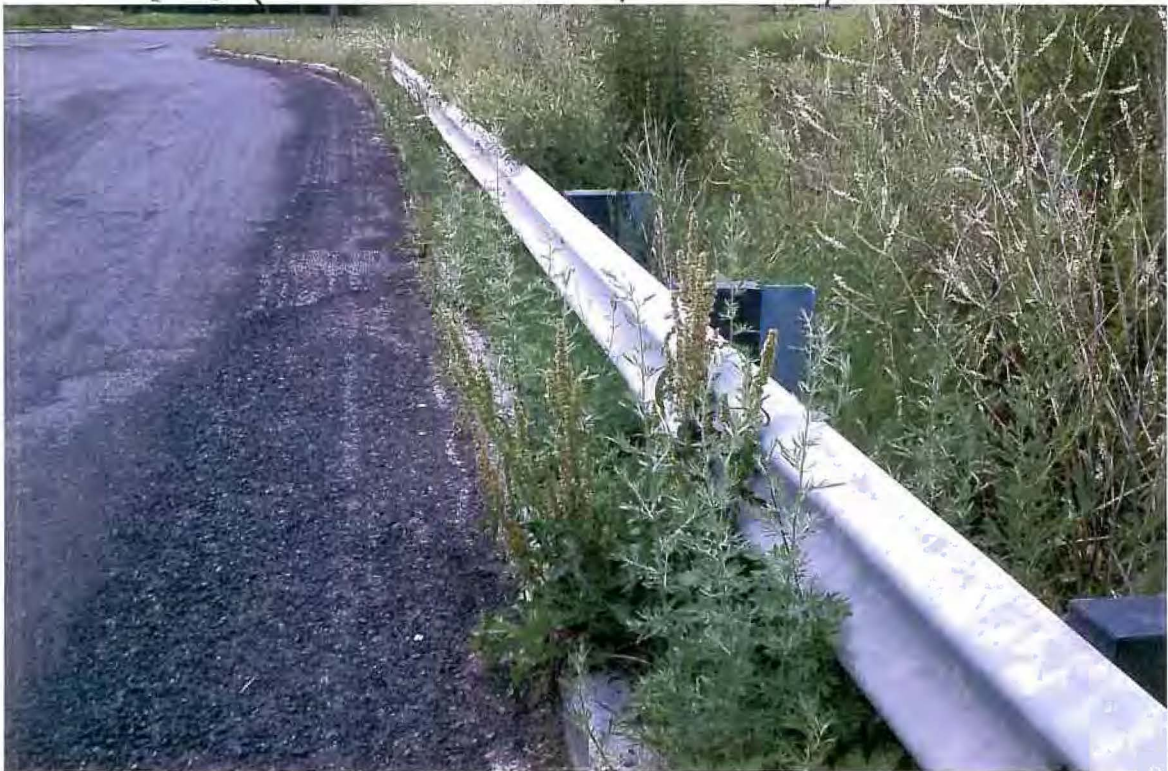
1 Purple Loosestrife

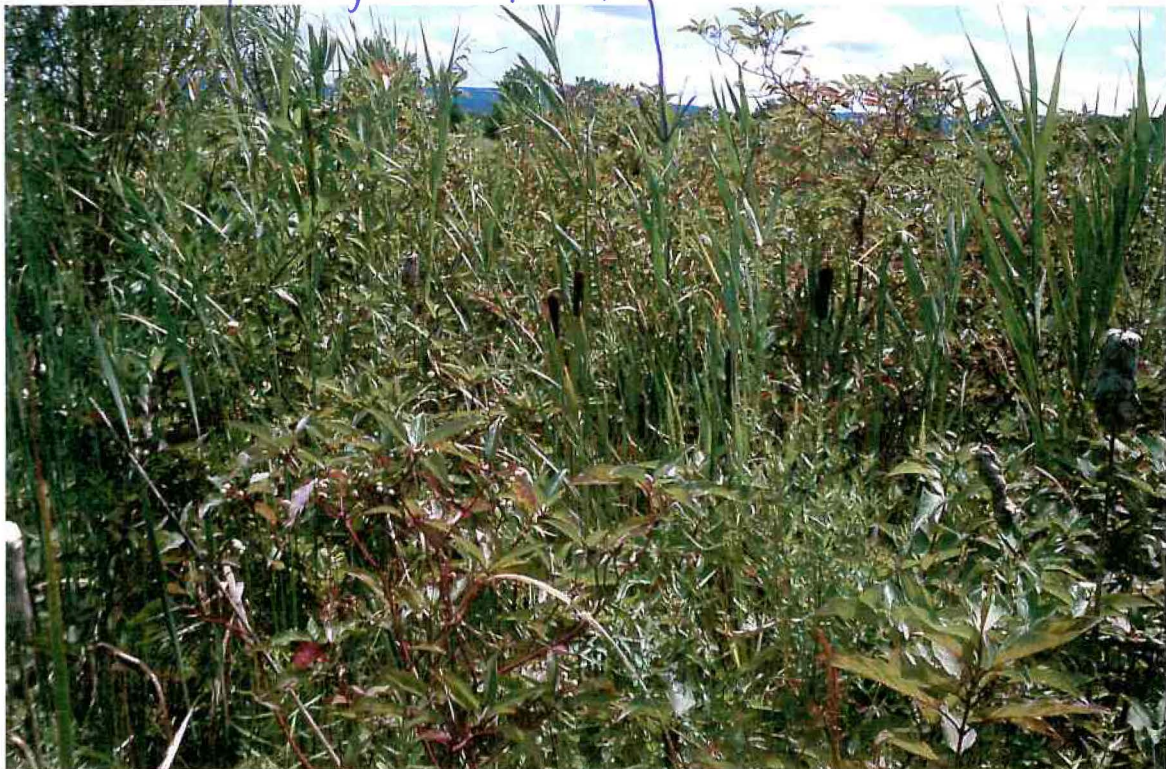
Purple Loosestrife

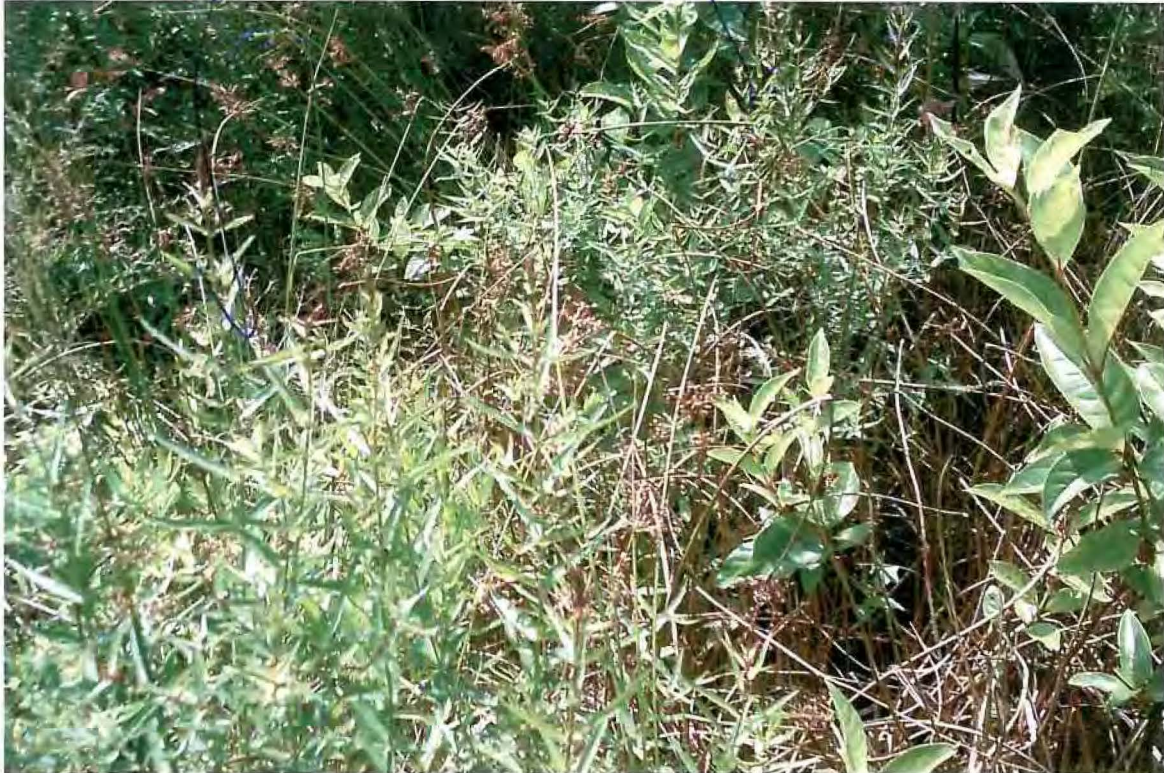
Purple Loosestrife

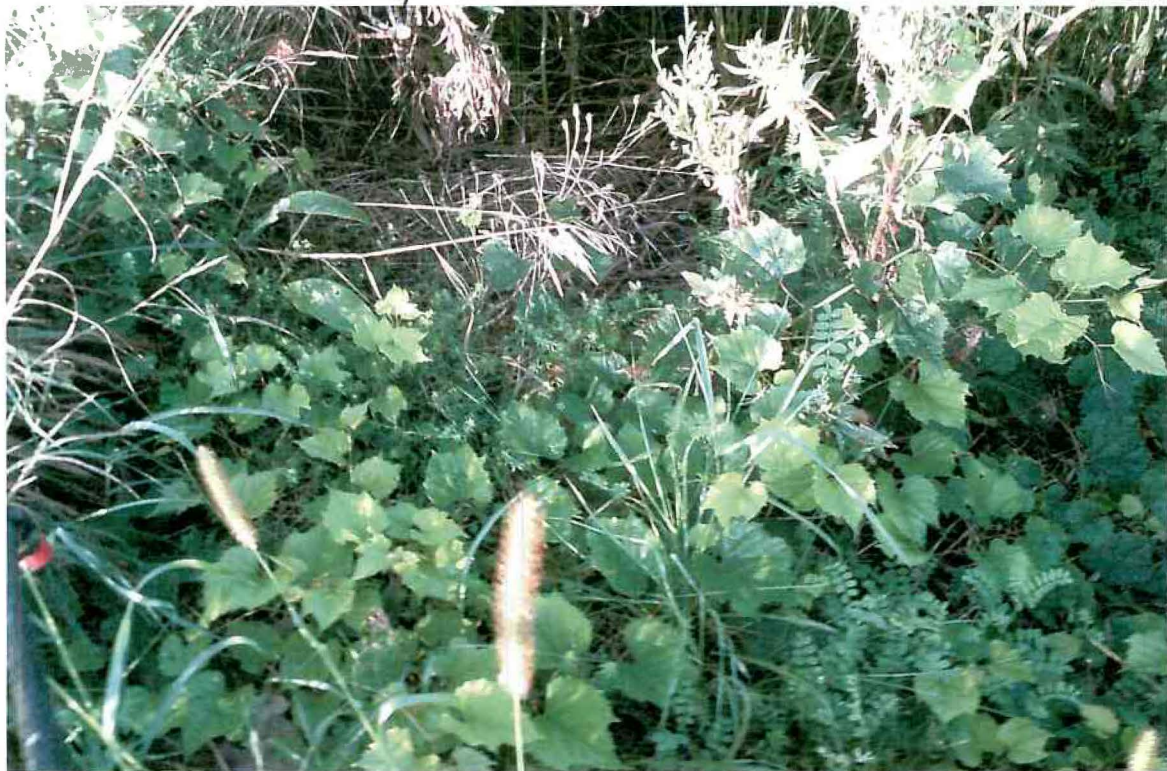
Purple Loosestrife

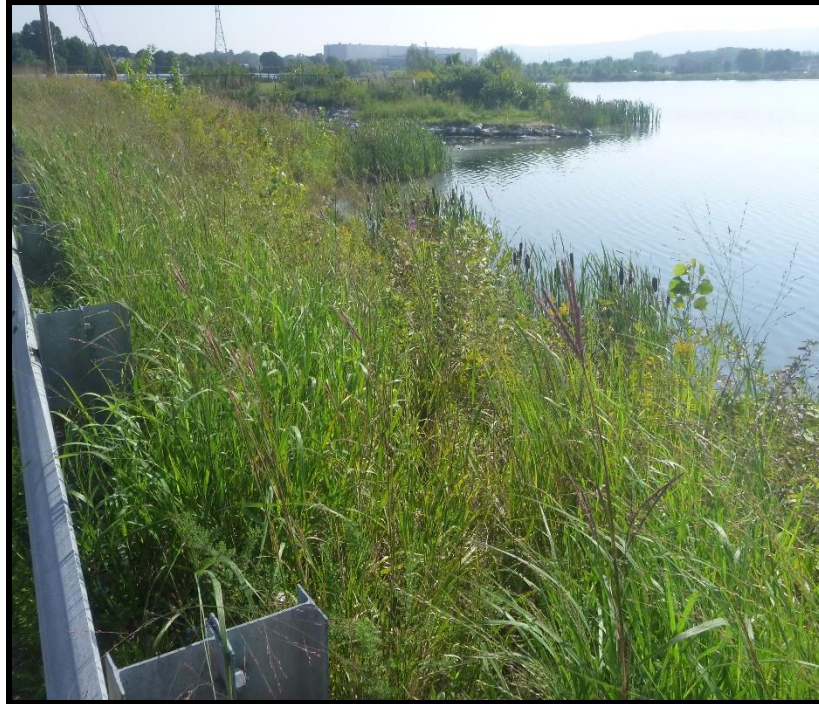
**Photograph 6: Water chestnuts observed in Silver Lake near PED A Outfall**
